**Product Bulletin**

**Subject: Facet International - Model FG-2XX-4 End Caps**

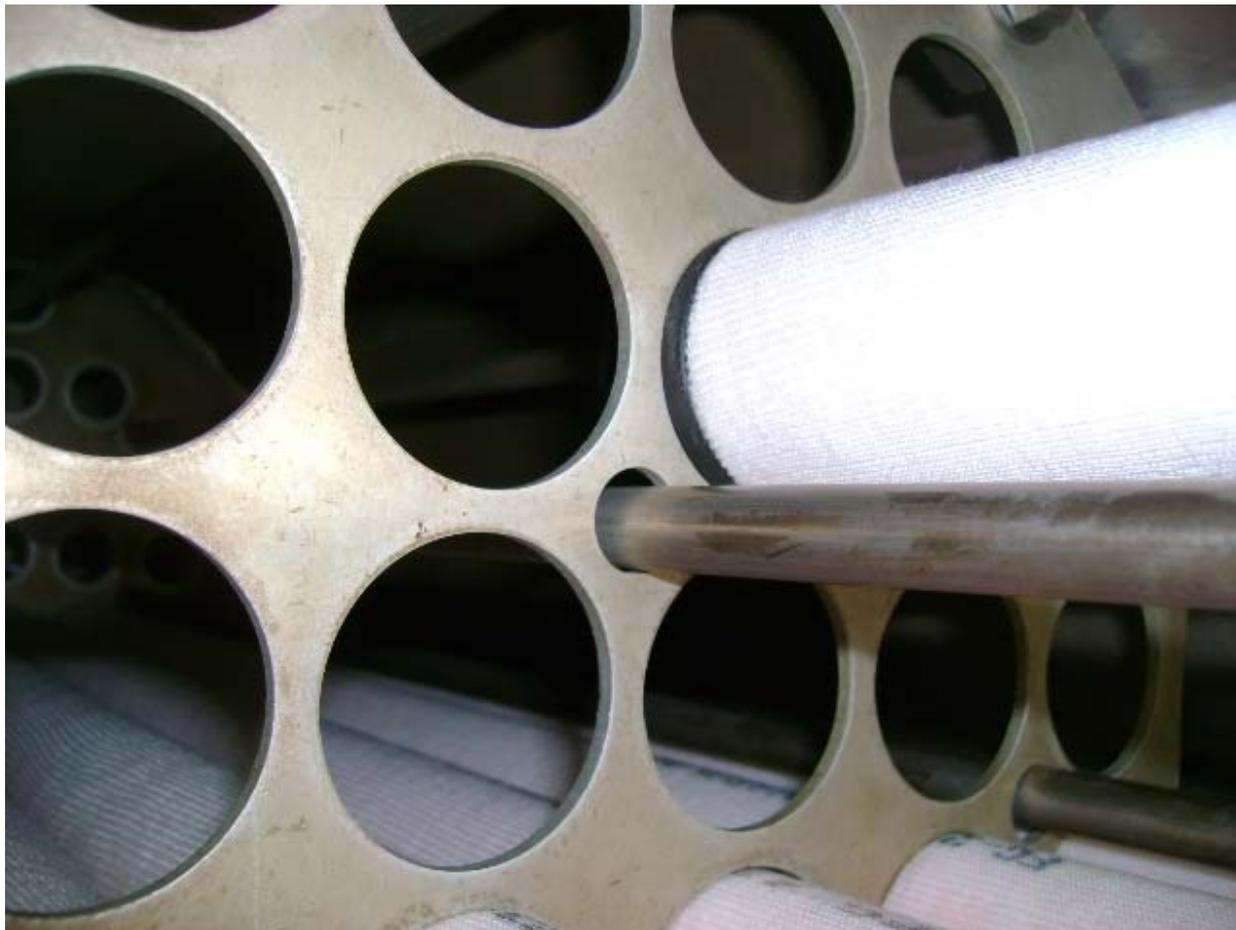
On September 14, 2009, Facet was made aware of an issue by Air BP Middle East. The bayonet end cap on Facet's 2" monitor elements was unable to clear this specific location's vessel guide plates (see attached picture). Investigation revealed both the bayonet and blind end caps of Facet's 2" monitors were approximately .020"/0.5 mm larger than specification. Furthermore, our investigation revealed the guide plates for these particular vessels did not allow "*sufficient clearance between the element outer diameter and the intermediate support grid.*" The combination of the two resulted in the interference. The issue has since been resolved.

As a result, Facet is releasing this bulletin to inform our customers that as of September 24, 2009 all 2" monitors manufactured from this date forward fall within the tolerance allowed by EI 1583. Please note, product made prior to this date meets all performance requirements set forth by EI 1583 and replacement of monitors in stock or already in service is **not** required.

Outside of this one instance, we have not been made aware of any other guide plate interference issues. In the event you do experience this issue, Facet will replace all required product and relevant guide plate along with any incurred freight fees at no charge.
